# Worcester Cathedral

Guild of Bellringers

## CLAPPER DATA

# WHEELER'S WOODEN WALLOPERS

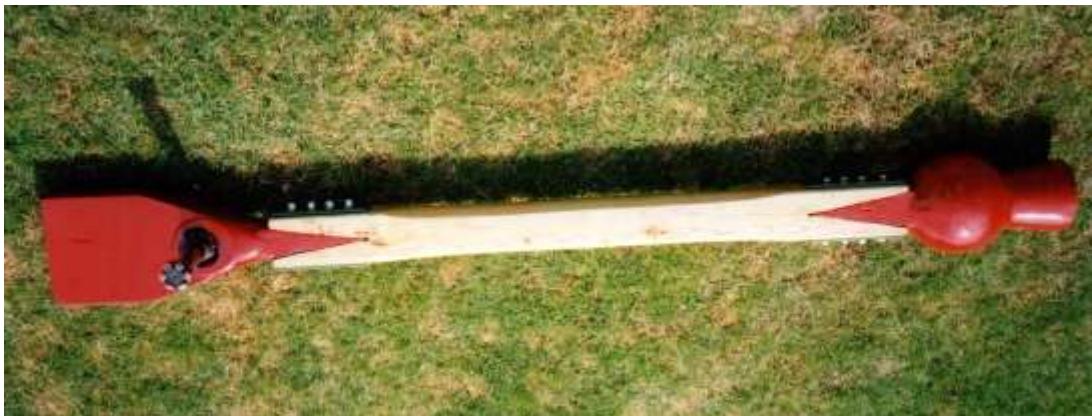
### Version 1 – May 2005

The tenor clapper had broken many times over the previous two decades and after another new one was installed in 2002, Jim took the broken SG one and welded it as an experiment. When another breakage occurred on Christmas Day 2004 this experimental one was pressed into service for a couple of months, with interesting results. Once a new slimline Eayre & Smith SG one<sup>1</sup> was in the bell, Jim carried on with his experiment – reasoning that wood was a better material for absorbing stress than (SG) cast iron he replaced the shaft with ash and used the existing ball and counterbalance.

The key features of this clapper are the **wedge section** of the joins and the use of **ball-races** at the pivot. The joins between the wood and the metal are the greatest potential weakness in a composite clapper but Jim's solution worked well, the only issue being the size of bolts used – the M8's used on the early models were replaced by M10's on later ones. The ball-races make for far more smooth-running than metal in a nylon sleeve and avoid the need for expensive rebushing at intervals.

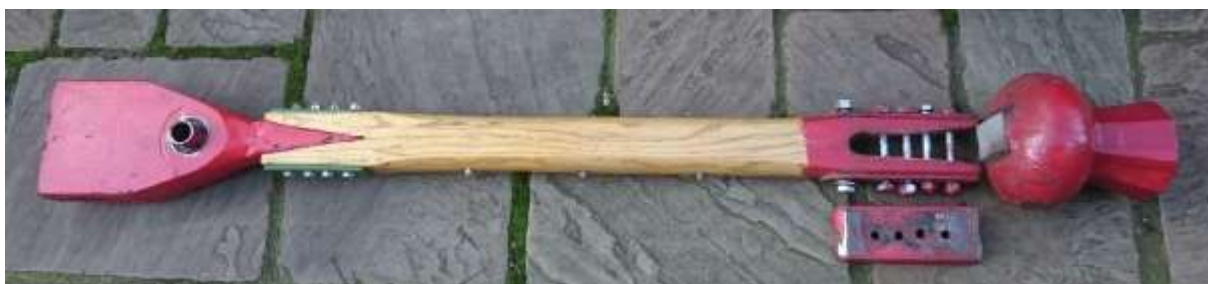
### Version 2 – Mar 2011

On 23 Dec 2019 after nearly 9yrs of impacts (including 54 peals), the 2011 ball sheared across the top where there is a change of section (see picture). Such a clean break suggests a casting flaw or excess stress which other Taylor balls have also suffered.

After the ball failed on Version 2 on 23 Dec 2019 during a quarter peal attempt it was decided to commission a new one rather than a replacement. It has a Philip Pratt ball

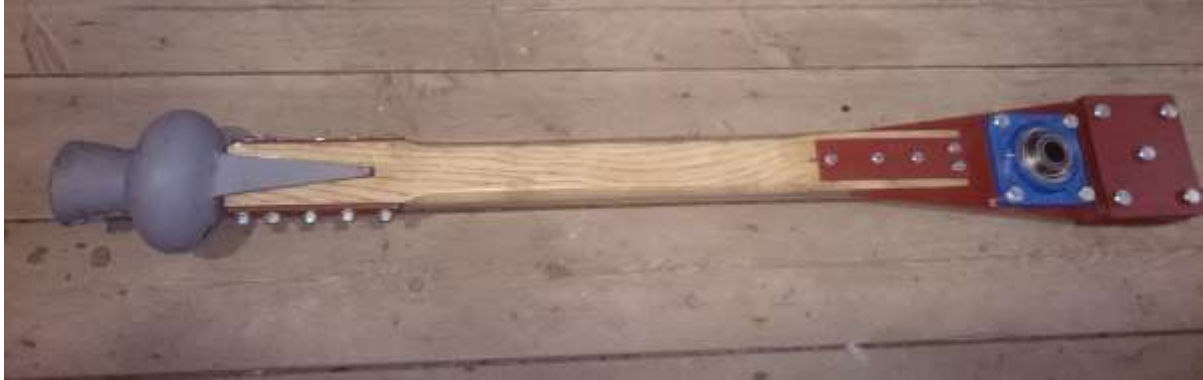
### Version 3 – Feb 2020

of **13.5kg** and copies the design Jim had created for our 10<sup>th</sup> and 11<sup>th</sup> bells in 2012 & 2015 - the counterweight consists of several separate steel plates rather than a single lump, so that it is adjustable if needed, a feature we made use of almost immediately.

Its natural strike time has turned out to be rather fast, at 545ms. Curiously whilst there was agreement that the SG clapper speed of 545ms made the bell more difficult to ring, there was also agreement that the new clapper made the bell easier, so clearly strike time is not the only issue *in that respect*. This clapper weighs 34kg in total, exactly the same as the first version.

The counterbalance was built up to six plates, weighing 8.2kg - the strike time is now **555ms**. By various metrics it is still too fast so we will either **increase the counterbalance or replace the staple with a shorter one**.

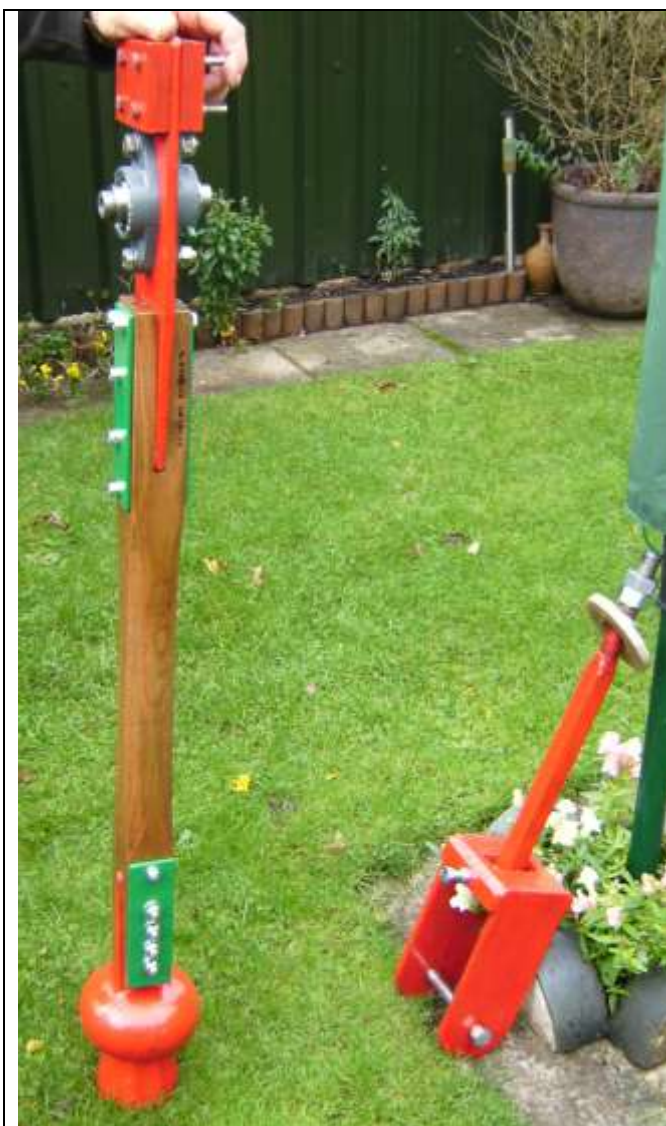
## WORCESTER 10<sup>th</sup> CLAPPER 2012

The 10<sup>th</sup> clapper at the Cathedral had suffered a significant number of breakages, the final straw being a last course breakage in a peal attempt on 18 Aug 2012.

After 3 years of use (including 30 peals) a problem arose with the ball and it was replaced by Taylor's about Nov 2015. The peal rung 19 Dec 2015, using the old repaired metal one, was rather fortunate as the next day the old clapper broke in the first touch of Sunday Service ringing, splitting the slider on its way out. Over 40 peals have now been rung on Version 2.

For this one Jim replaced the staple as well as the clapper itself, using his new 2008 design, with the staple independent of, and adjustable against, the staple bolt. The clapper features an adjustable counterbalance, made of plates rather than a single lump, and had a Taylor ball of 11.8kg. It was installed **autumn 2012**.

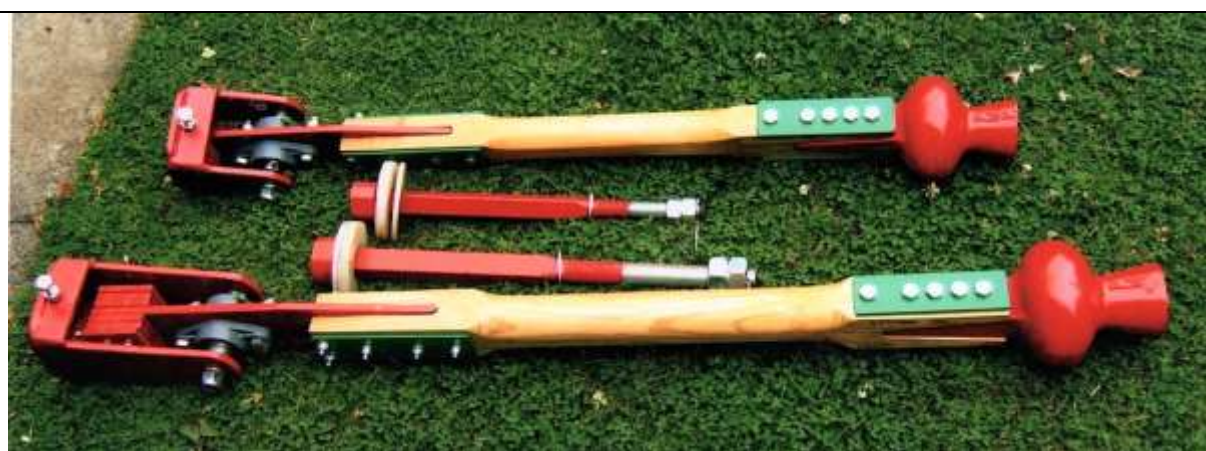
### WORCESTER 9<sup>th</sup> and 11<sup>th</sup> CLAPPERS 2015

The 9<sup>th</sup> bell is quite large for its position in the ring and has always been one it is necessary to 'push along'. The new clapper made it easier to ring, but when all the clapping was being adjusted in 2019-20 it was speeded up a bit further, shortening it by 1.5cm, and moving the staple outwards. The composite nature of the clapper made this easy to do on-site. The 11<sup>th</sup> was speeded up slightly also, but only by packing out the staple, increasing the Clapper Throw.

Features as for 10<sup>th</sup> clapper. The 11<sup>th</sup> has a counterbalance, the 9<sup>th</sup> does not.  
Clapper balls for both from Philip Pratt, 8.6kg and 10.5kg
