CREATING A WELL BALANCED RING Part 2 - Clappering

In our quest to make the heavy twelve at Worcester a more balanced ring, over a period of months we first altered the swing times of several of the bells (see Part One) and then looked at their clappering. The back bells had been vastly improved with the introduction of Jim Wheeler's wooden-shafted clappers between 2005 and 2015 and whilst there was no plan to replace all the others (!) there were obvious possibilities to improve their performance.

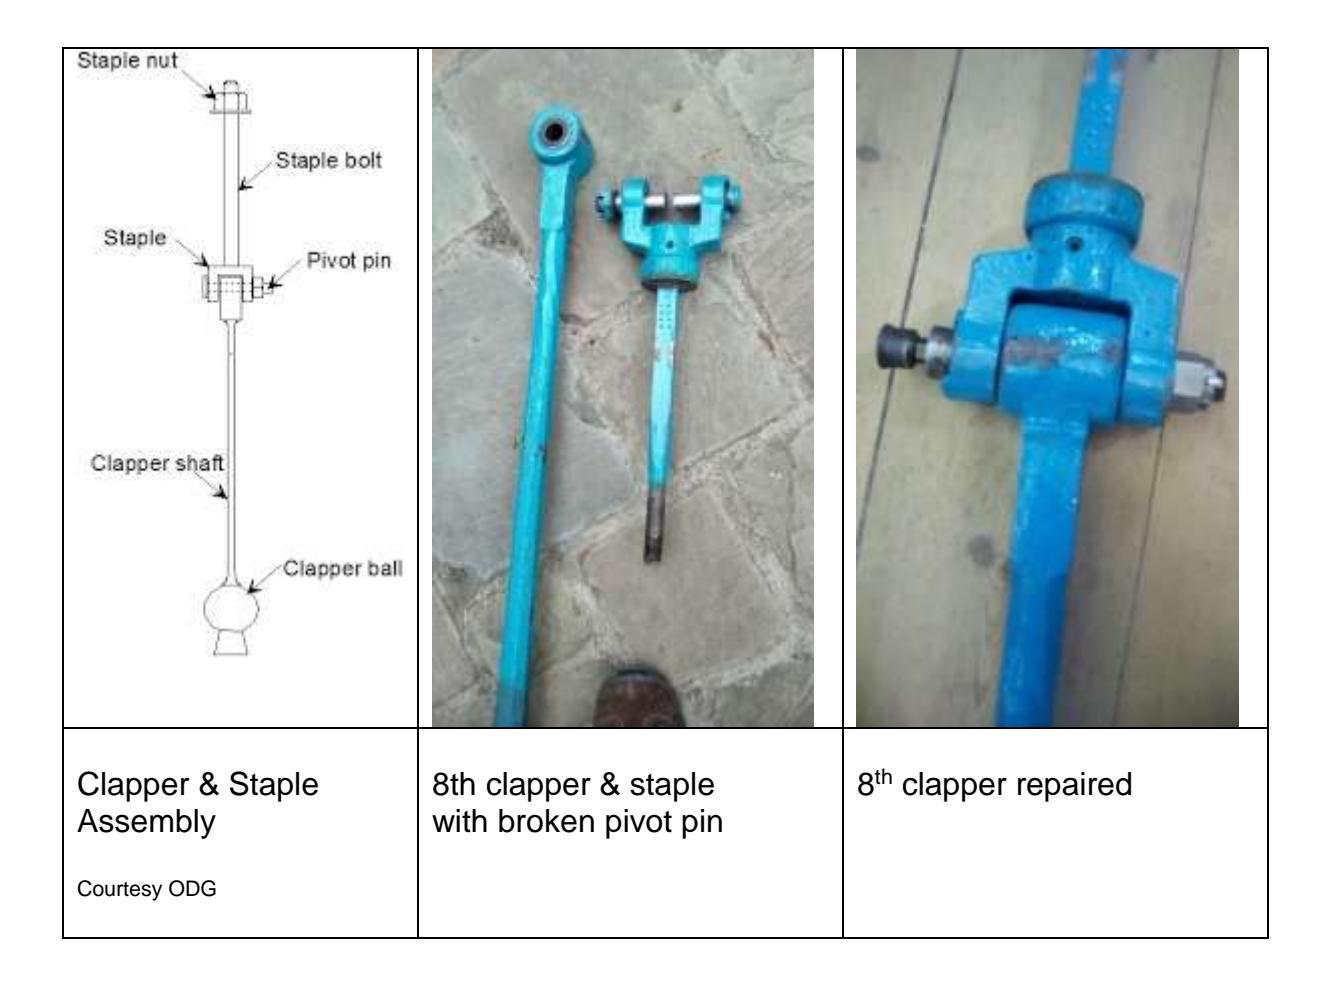
The steeplekeeper can do quite a lot about the ease of movement however – a year before starting this exercise we removed the twelve wrought iron clappers and staples, dismantled, cleaned, lubricated and then re-installed them. The pivot pin of the 8th was found to be broken and had to be replaced by Whites. The back four bells have wooden-shafted clappers with pivots in ball-races which need no such attention! We did, however, clean and lubricate the old clappers for these bells so that they are available for an emergency.

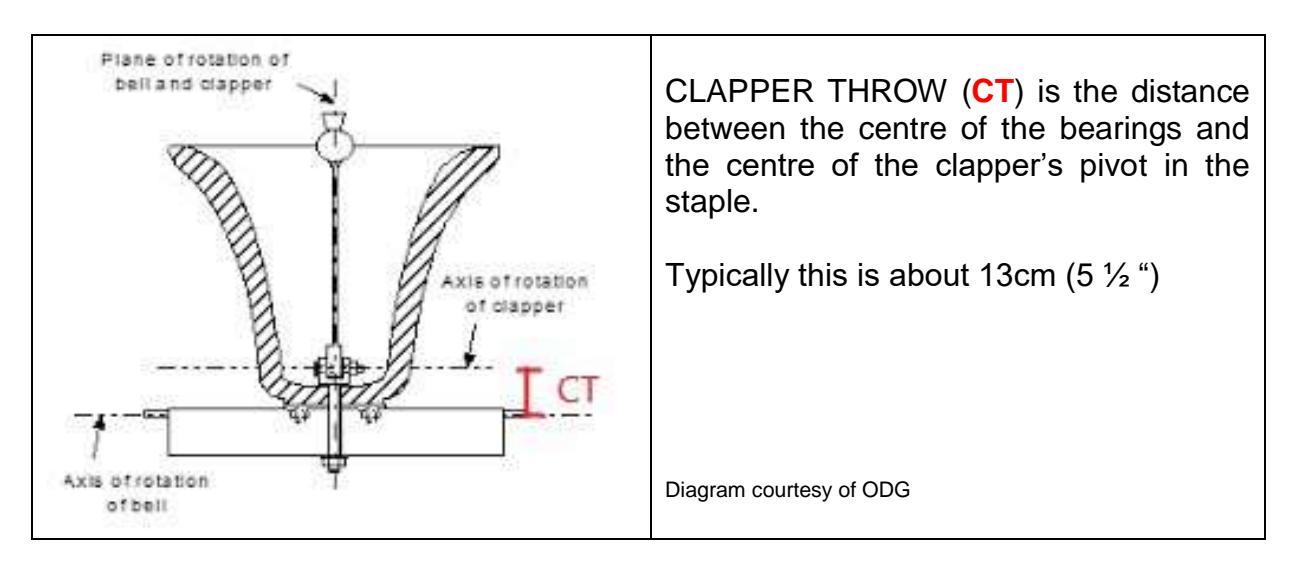
As it turned out, we were in the fortunate position of needing only to <u>speed up</u> clappers - increasing the CT's by packing out the staples from the bells. The smaller adjustments, increasing the CT by up to $1 \text{ cm} (\frac{1}{2})$, could be implemented without any change to the clapper but did usually require a longer staple bolt. For the larger adjustments the clapper had to be shortened in order to keep the strike point of the ball in line with the strike point on the soundbow of the bell. Luckily we have access to a forge and a Jim Wheeler!

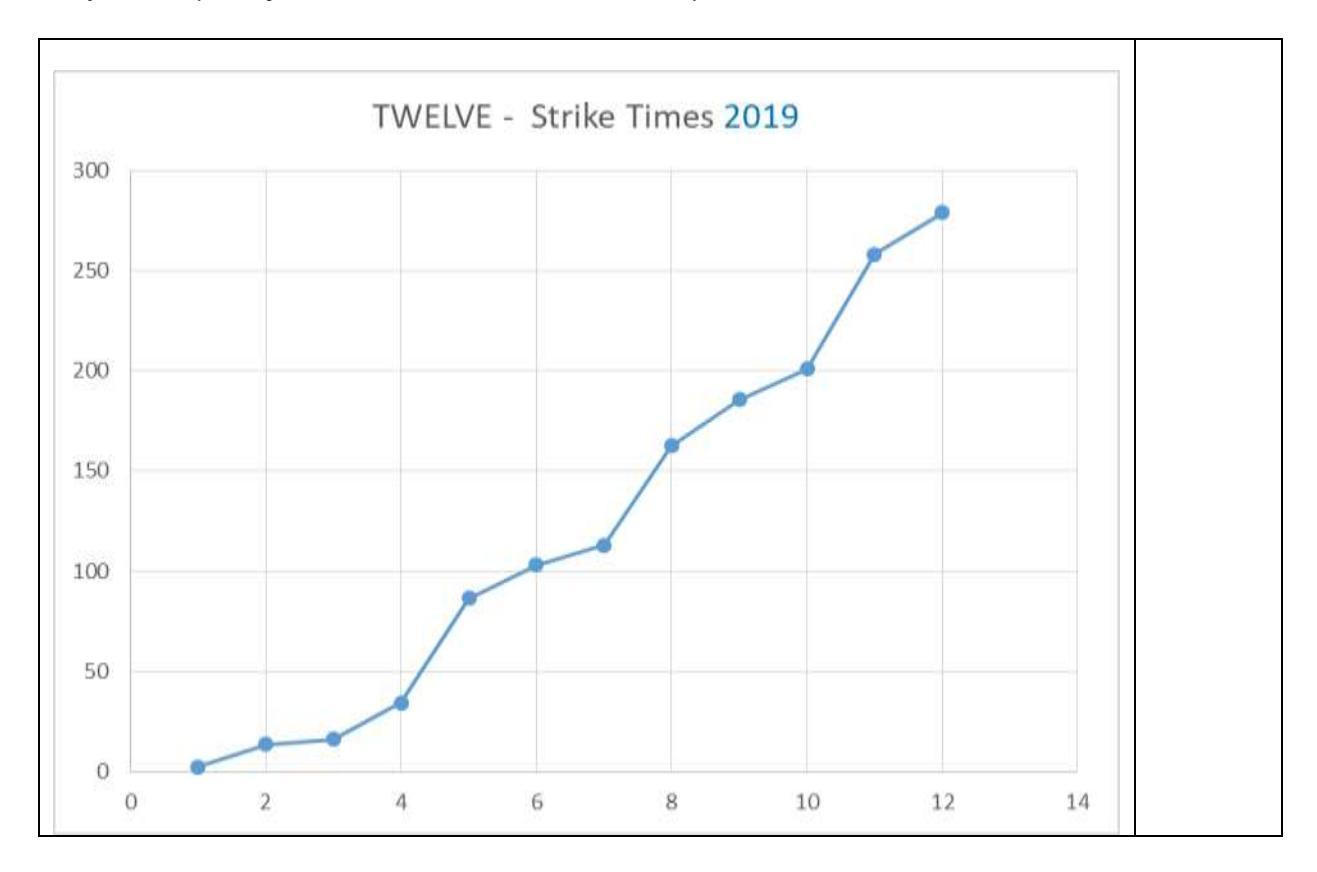
As shown on this graph the **strike times** were anything but a smooth line. These are <u>mean</u> strike times, making any oddstruckness between handstroke and backstroke irrelevant. They were taken on 4 Sep 2019, after the Bell Swing Times had all been adjusted. *(The y-axis is milliseconds less 300).*

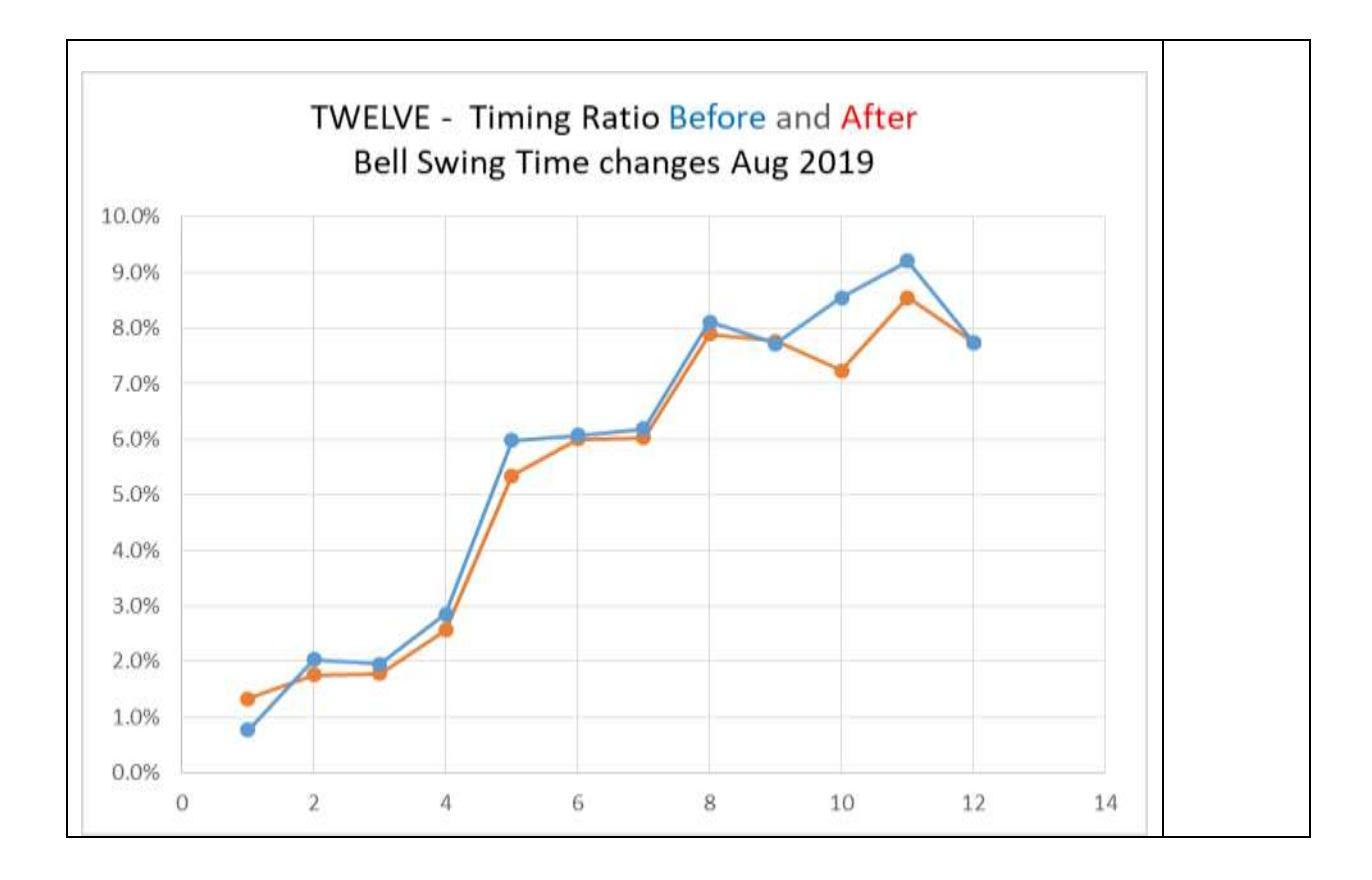
Whilst making our adjustments in order to smooth this line out we also started to use another metric, the ratio of the **Strike Time to the Bell Swing Time**. (As this is something of a cumbersome title it is abbreviated on the graphs to **Timing Ratio**). It doesn't take much thought to realize that this captures in one number the essence of what the ringer experiences – how long his bell takes to move and how long it takes to sound. For Worcester this is in a range of about 18-26% and the graph of this ratio captures, in more vivid style, how much adjustment the clappering required. Just to check whether our swing time adjustments (see Paper 1) had messed up this measure we compared it before and after those changes were made. Only in the case of the 10th does it appear to be significantly different. *(The y-axis is percentage less 17).*

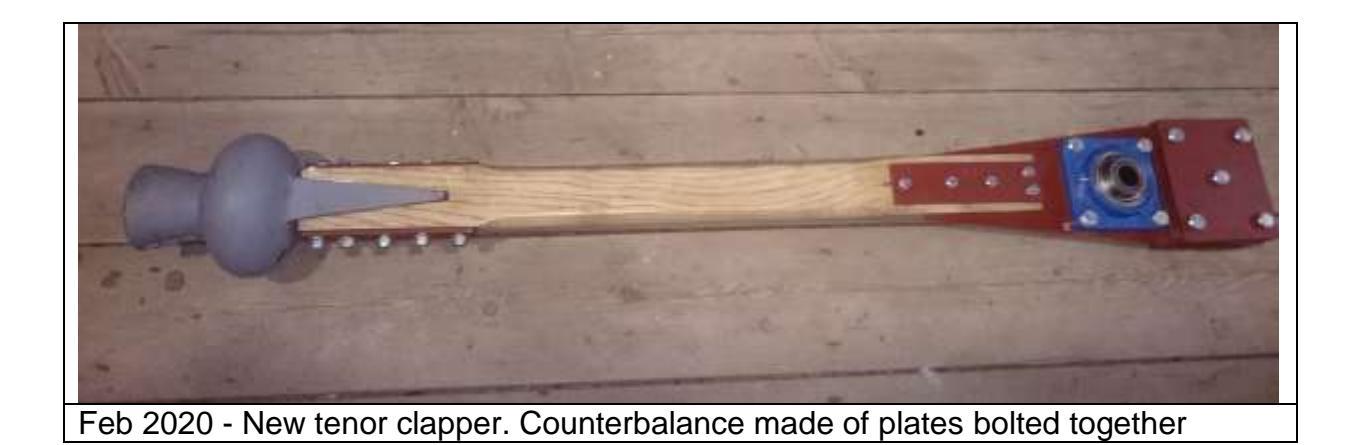
TENOR - Just as we were making good progress a major unplanned addition to the work was created when the clapper ball of the tenor broke during a quarter peal attempt on 23 Dec 2019. This was the second (heavier) ball used on this clapper and had done 8 ½ years' work, whilst the first had lasted 5 ½ years. The breakage seemed to be due to a casting flaw rather than the design of the wooden-shafted clapper and was like fractures in other similar clappers. For various reasons, the repair turned into a <u>complete replacement</u> with an adjustable counterbalance like the ones we have on the 10th and 11th. We were hoping that the clapper strike time would be near the 579ms of the broken one but even after some initial adjustment it was a rather faster 555ms.

One oddity is that the old SG clapper used as a temporary replacement for two months has a similar strike time to the new clapper but the bell was harder to ring. It would be good to know why this is so.

So it does need slowing down, either by adding further to its counterbalance or reducing the clapper throw which requires a new staple. All three versions of the wooden-shafted clappers used in this bell have been hung on the old staple so it is a good opportunity to upgrade to an adjustable one. The timing shown on the graph represents where we want it to be at 577ms when circumstances allow us to do this work.
