## **WORCESTER CATHEDRAL**

### **Statement of Needs**

## **Bell Frame Improvements**

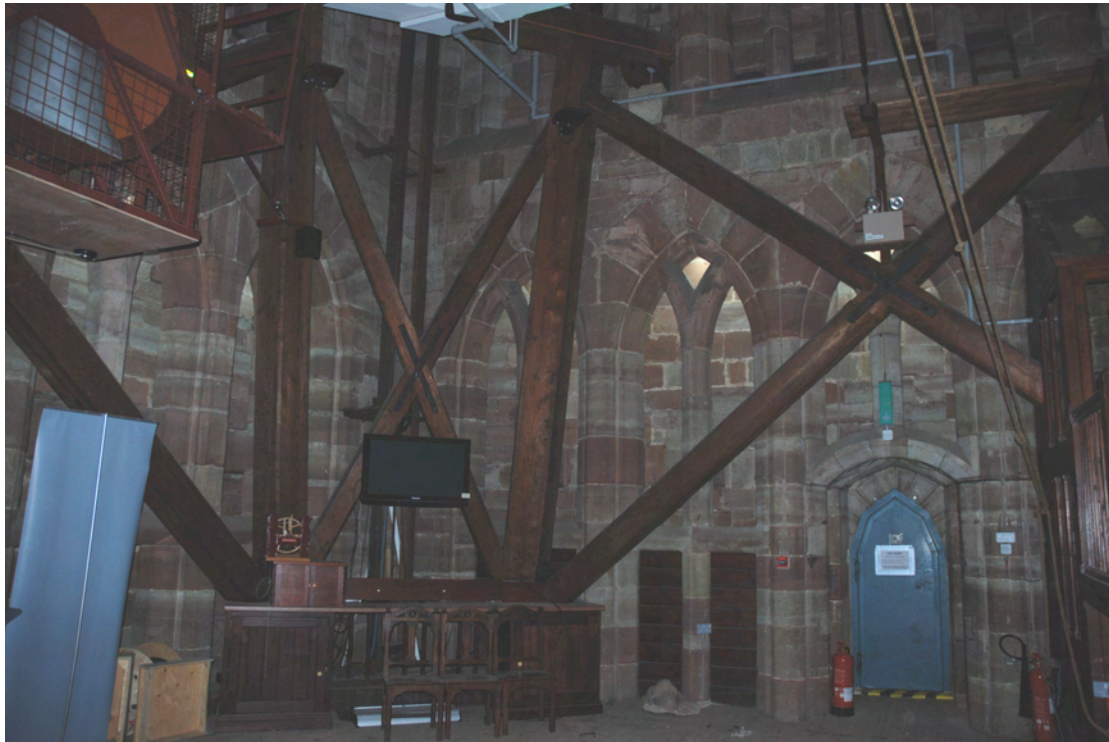
*The wigwam at Clock Chamber level*

The Wigwam is essentially square in plan with chamfered corners and a very large post at each corner.

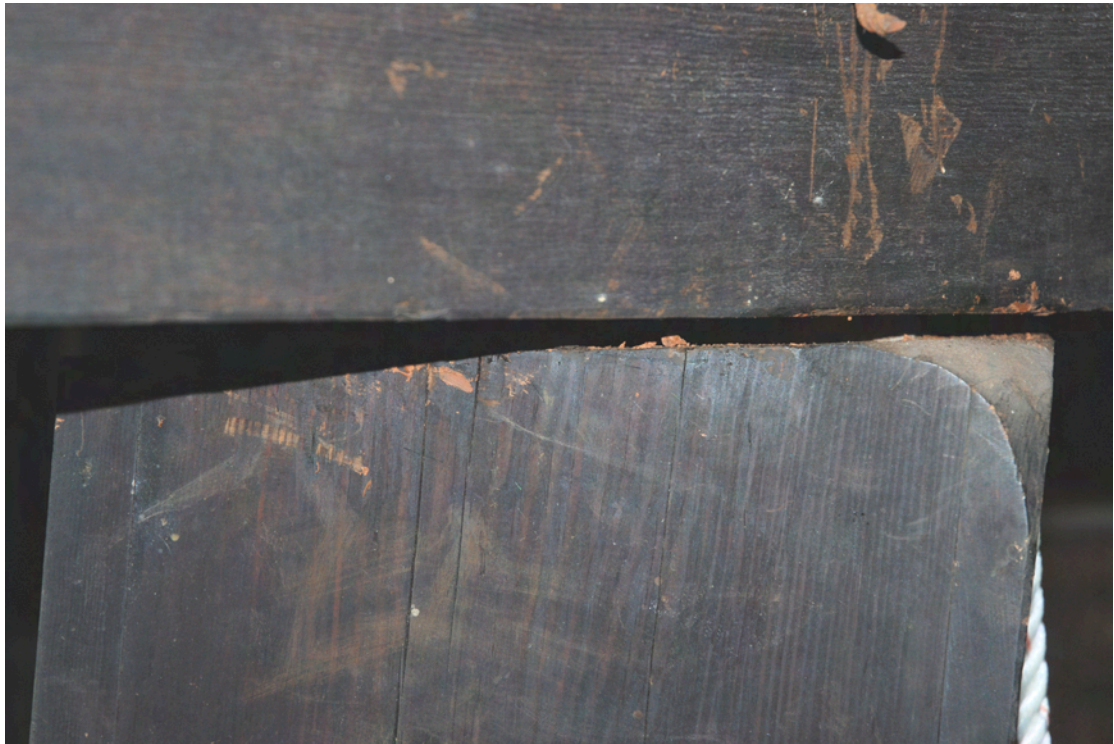
The bell frame is constructed of oak beams and posts/struts with steel cleats, tension rods etc. It is supported on large softwood foundation joists, mostly 300 x 350mm. These in turn are carried by diagonal bearers of similar size, at each corner of the tower. These bearers sit on top of the wigwam posts with morticed joints but the ends are supported on stone corbels built into the masonry.

*Tapered joint at top of Wigwam post*

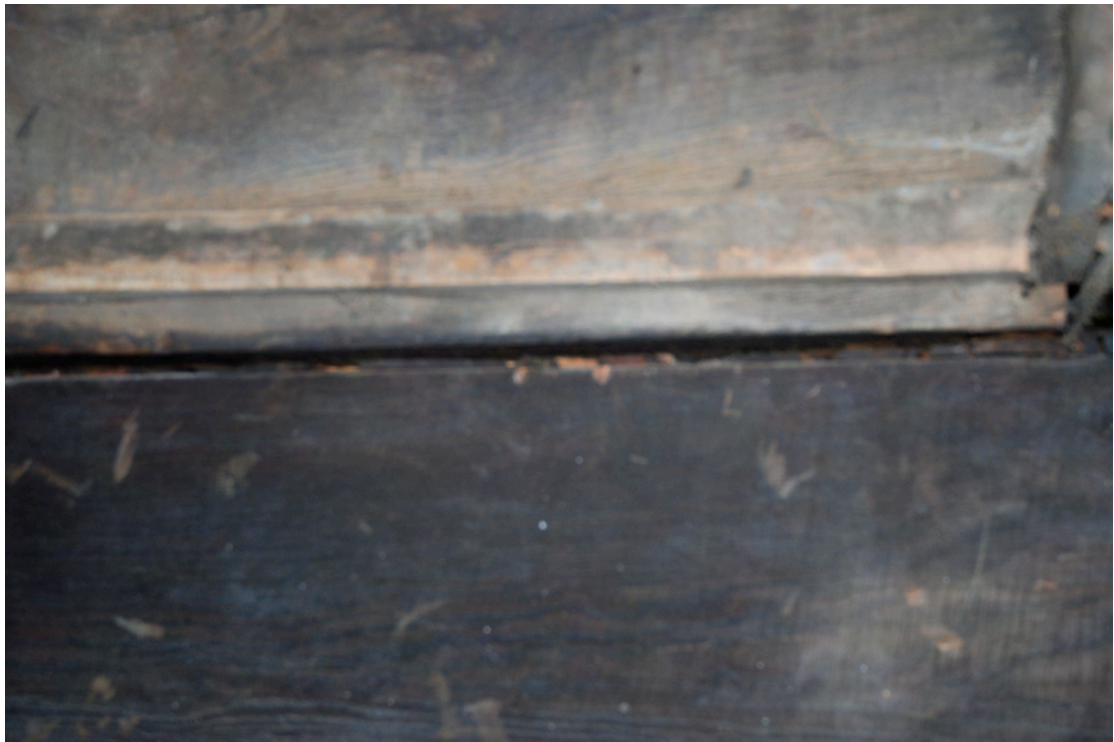
The different behaviour of the oak frame and the softwood supports has resulted in twisting and bowing where they come into contact, resulting in high point loads, in the cases of twisting and in some cases lack of contact altogether. The frame below the tenor bell, in the south west corner is almost completely unsupported. Motion of the frame is imparting some movement to the diagonal tie beams with resultant abrasion at the end bearings.

*Complete lack of contact between bell frame and foundation beam*

The bellringers have devised a non invasive and reversible method of clamping the lifted joints and a combination of clamps and bespoke steel wedges where twisting has occurred.

The form of these clamps is a pair of mild steel channels, one above and one below the timbers where they cross, and two vertical large diameter threaded stainless steel rods one each side of the beams. These rods will be fitted with washers and nuts and tightened to correct some of the twist or to bring the frame timbers and the foundation joints back into contact. Those joints which cannot be corrected by clamps alone will have mild steel wedges machined to match the geometry of the gap. This method will then distribute the load on the joint to the full area of the joint faces. These wedges will not be forced into place as this would impose further stresses on the timbers.

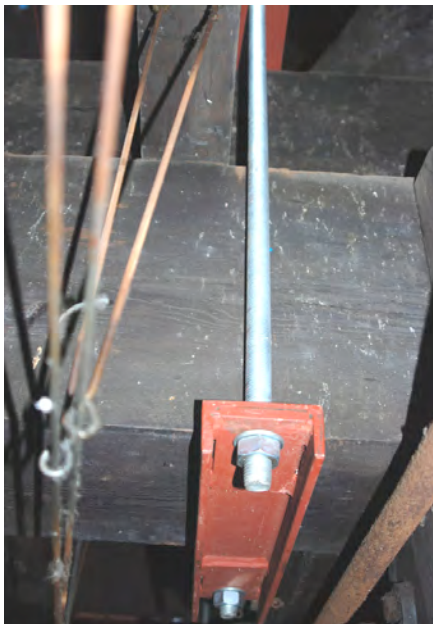
SECTION

100 x 50 mild steel channel above and below joint between beams

25mm dia grade 316 stainless steel threaded rod with washers and nuts

purpose made machined tapered mild steel shim to uneven joint to give full load transfer from upper to lower beam

existing upper timber beam

existing timber lower beam
