CREATING A WELL BALANCED RING Part 2 - Clappering

In our quest to make the heavy twelve at Worcester a more balanced ring, over a period of months we first altered the swing times of several of the bells (see Part One) and then looked at their clappering. The back bells had been vastly improved with the introduction of Jim Wheeler's wooden-shafted clappers between 2005 and 2015 and whilst there was no plan to replace all the others (!) there were obvious possibilities to improve their performance.

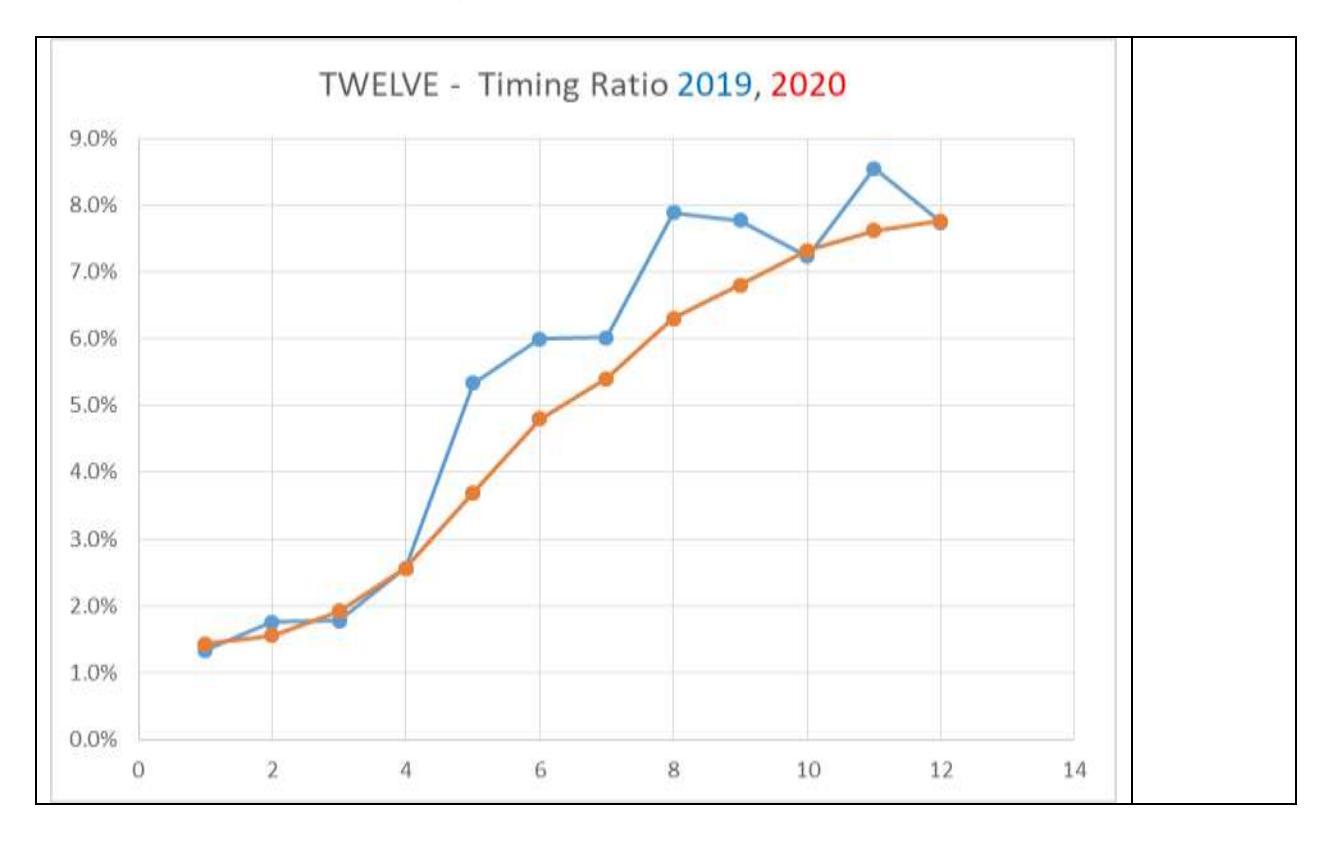
All graphs show the **Timing Ratio** as a percentage (*less 17 for display purposes*). Because the project has been interrupted the data for **5#**, **6**th, **6b and 7**th represents work done by 24 Mar 2020 but not confirmed by measurement and that for the 2nd, 3rd, **2# and tenor** are the targets for planned work when it becomes possible.
